**NATIONAL
TRANSPORTATION
SAFETY
BOARD**

AIRCRAFT ACCIDENT REPORT

**PANAMERICAN WORLD AIRWAYS, INC.,
CLIPPER 759, BOEING 727-235, N4737,
NEW ORLEANS INTERNATIONAL AIRPORT
KENNER, LOUISIANA
JULY 9, 1982**

NTSB/AAR-83/02

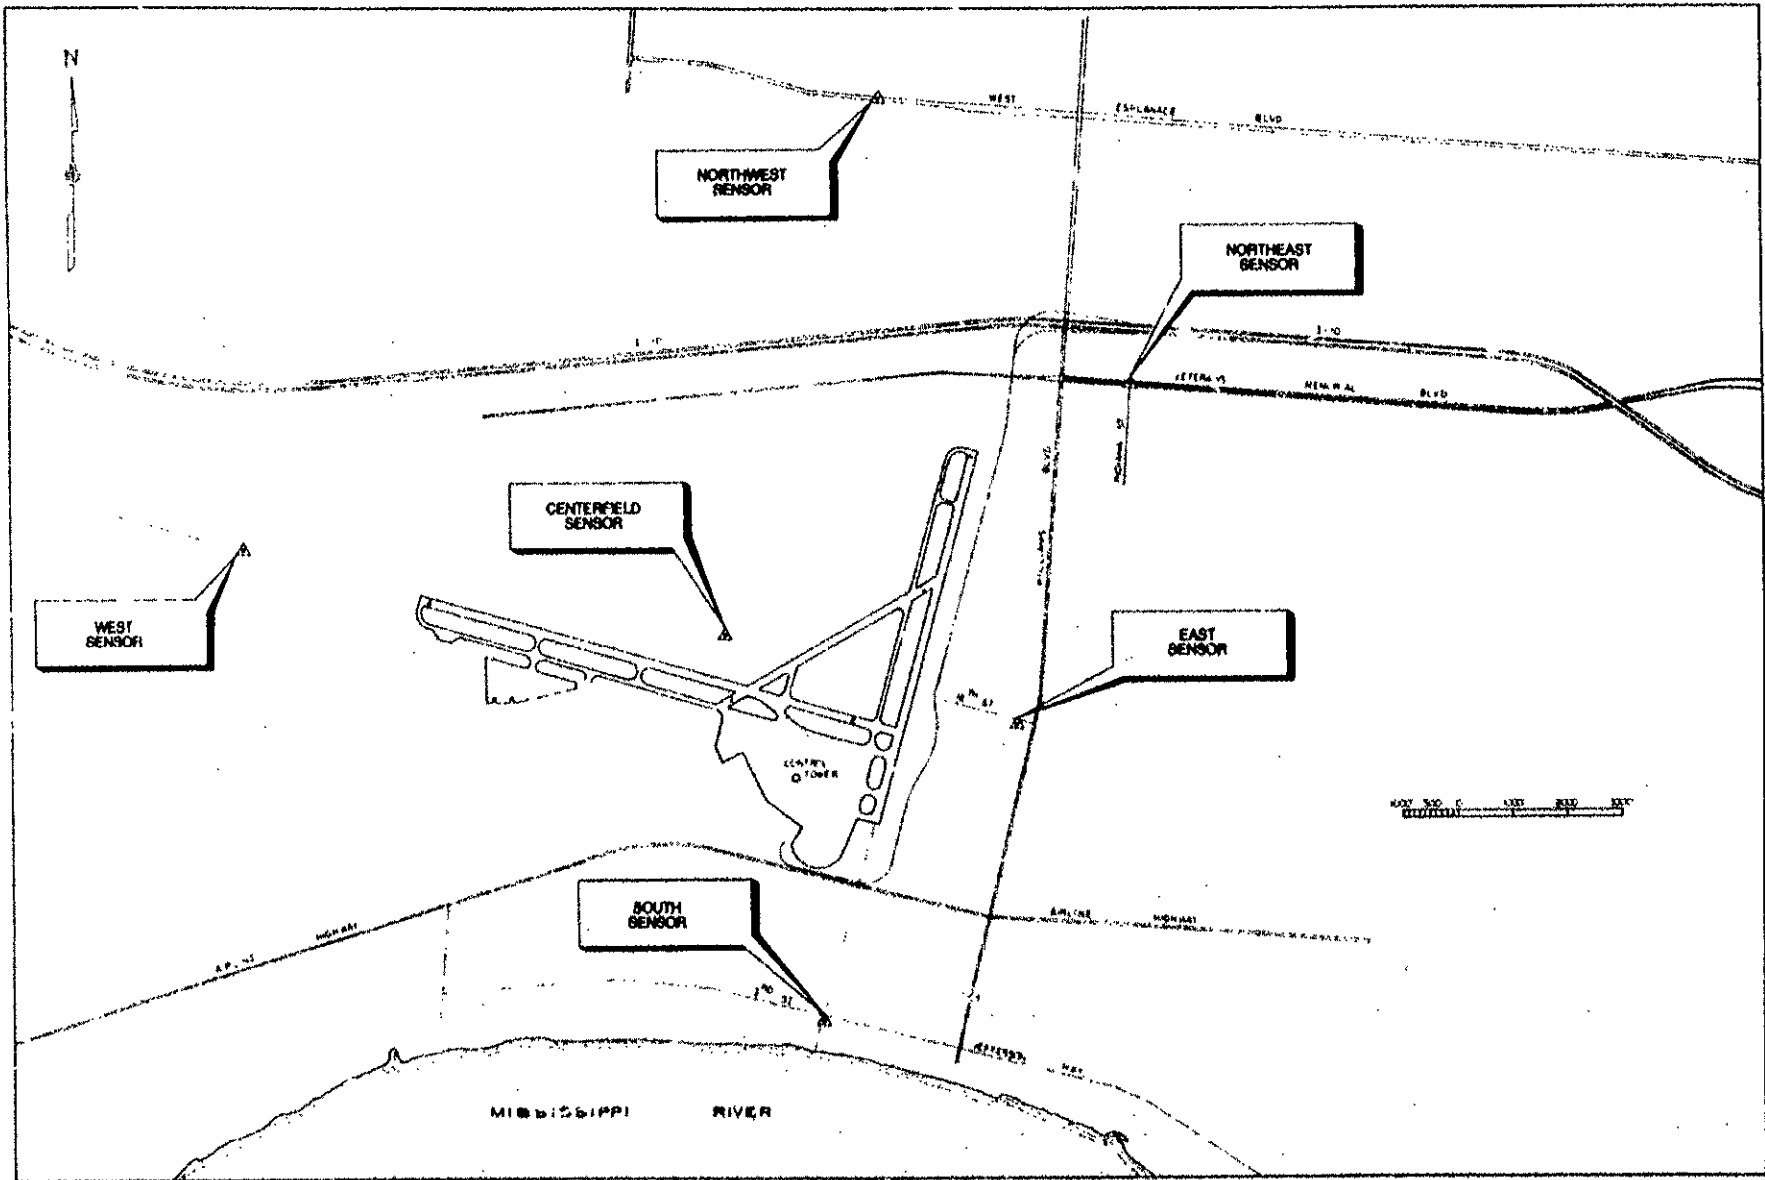
Figure 1.--Low Level Wind Shear Alert System at New Orleans International Airport.

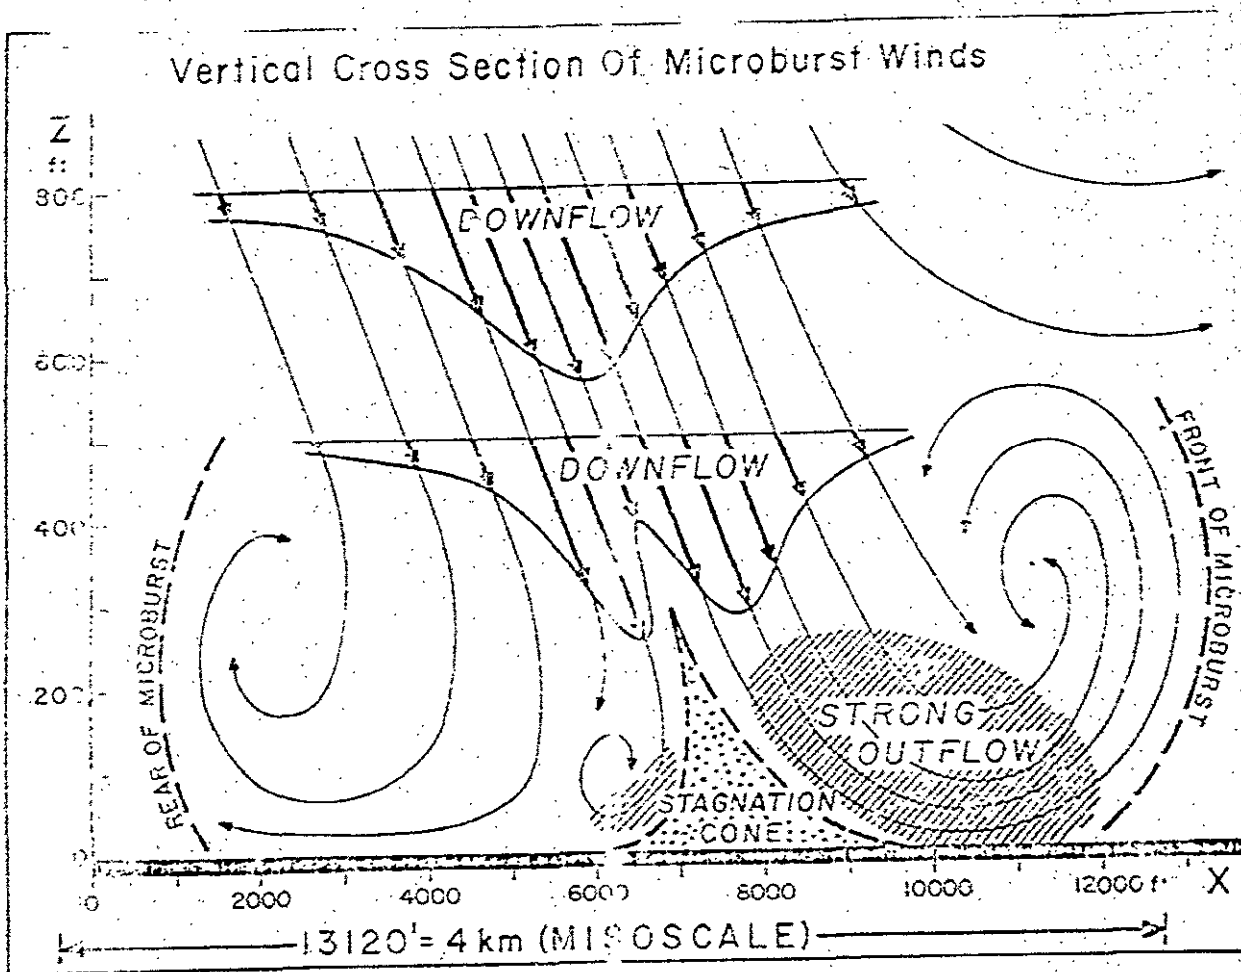
Figure 3.—Vertical cross-section of a microburst.,
("Microburst Wind Shear at New Orleans International
Airport, Kenner, Louisiana, on July 9, 1982." p. 30, Dr. T. Theodore Fujita.)

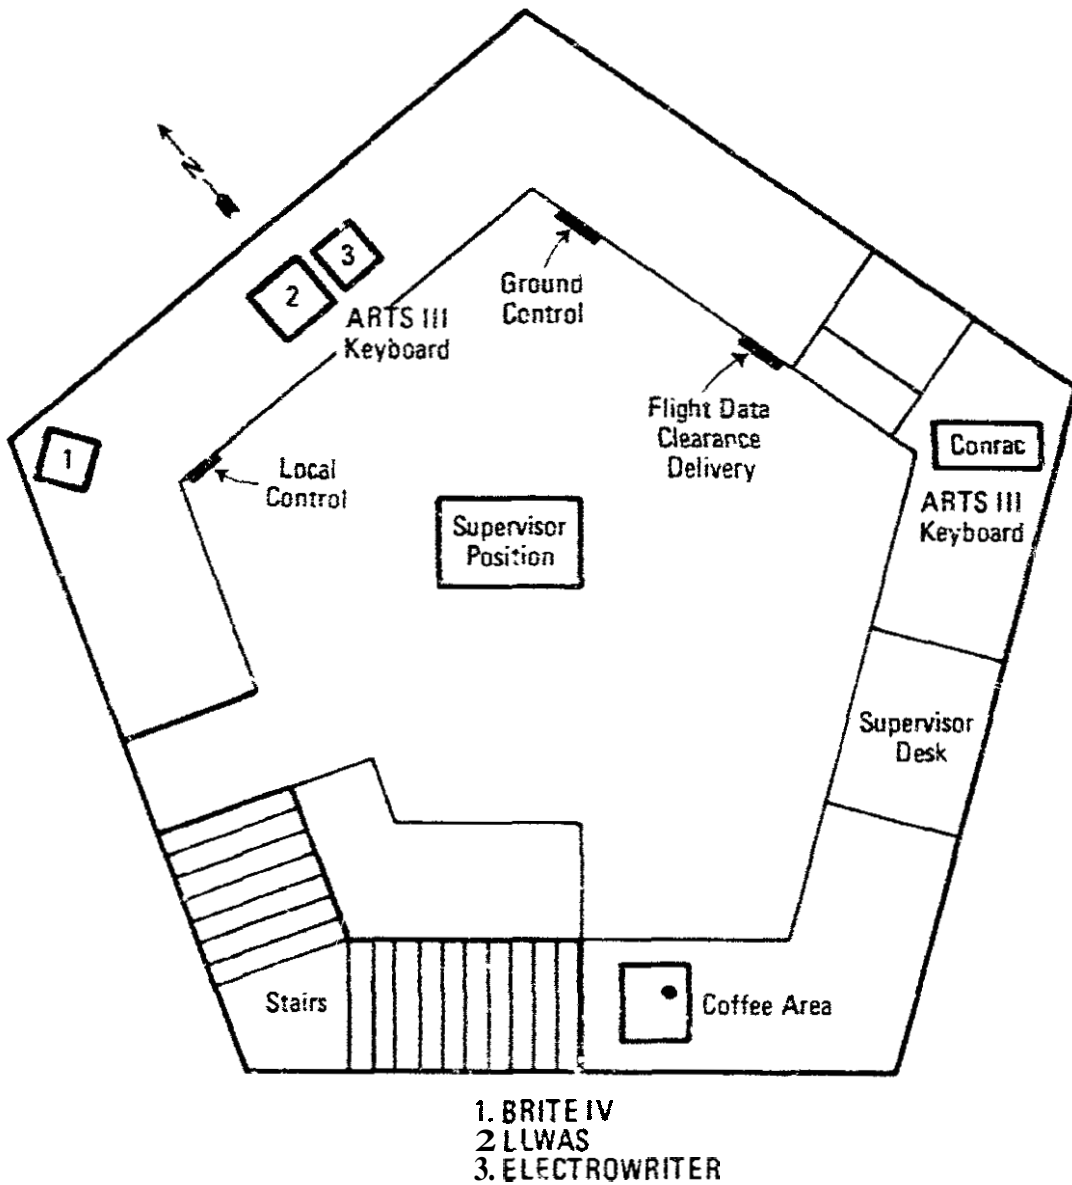
Figure 5.—New Orleans International Airport tower cab layout chart.

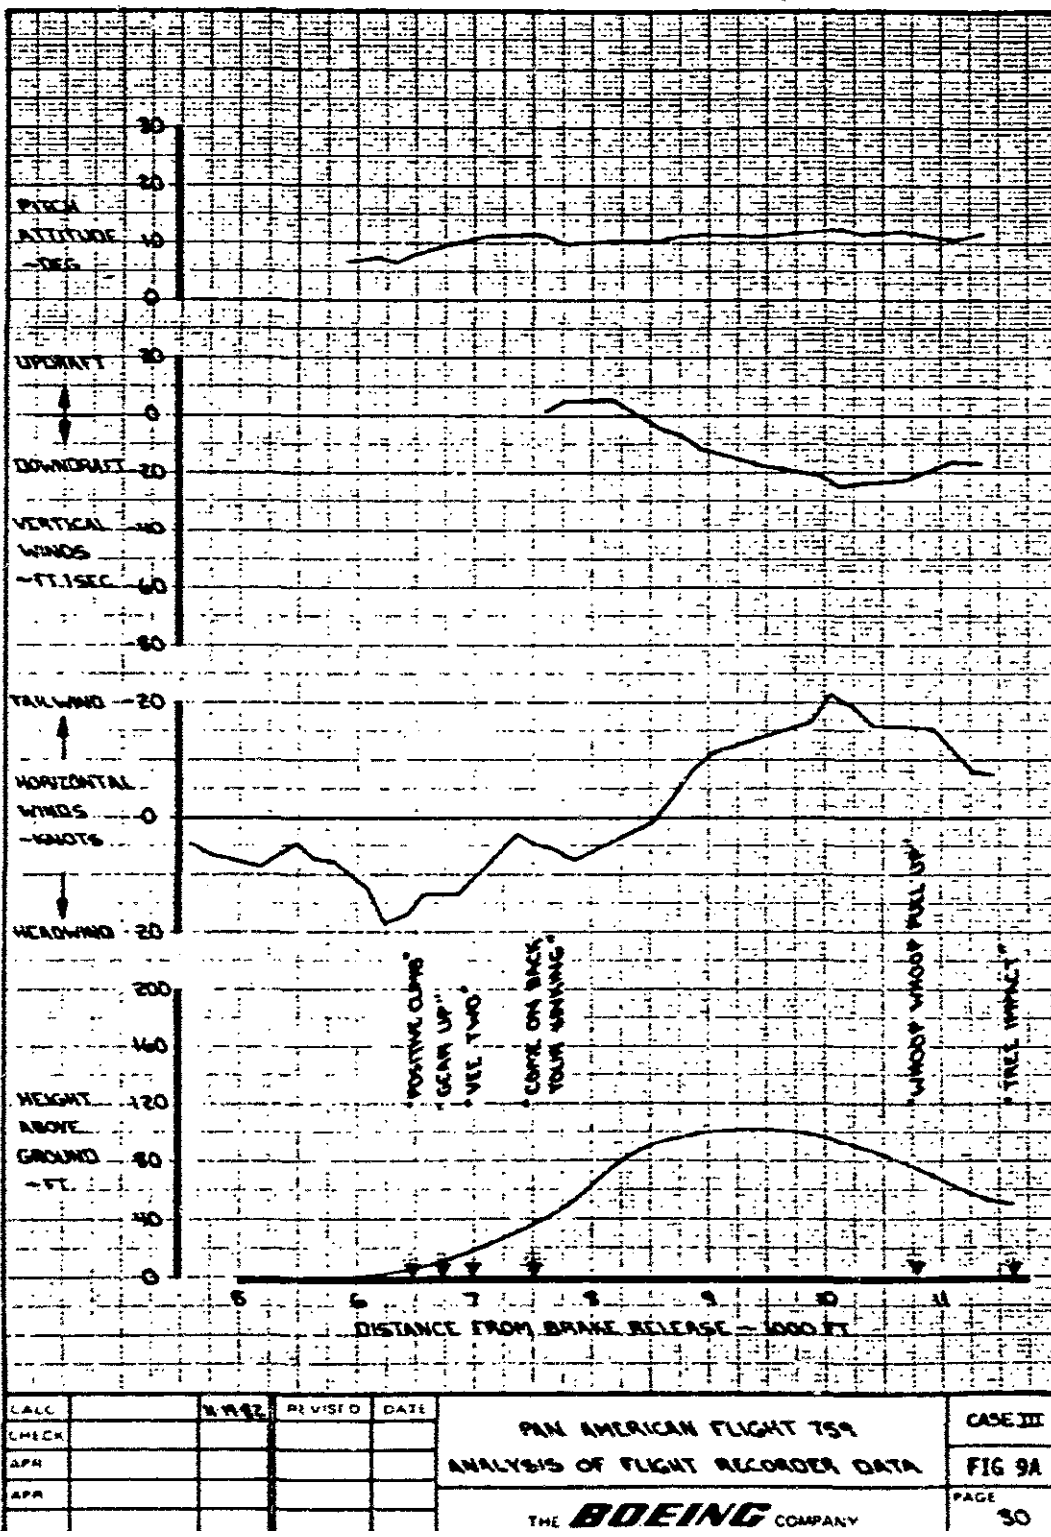
The major difference between the derived windfields in the Boeing performance analysis and those reflected in the Pan Am and NOAA wind analyses was the wind speed of the downdraft at 100 feet AGL. In addition, the airplane pitch attitudes reflected in the Pan Am analysis were different from those shown in the Boeing analysis. In the Boeing performance analysis, the speeds of the horizontal and vertical wind components and their spatial relationship to each other were adjusted by assuming groundspeed time histories which insured that the airplane's flight met the constraints imposed by the physical evidence of the accident sequence. Airplane pitch attitudes were

Figure 6.—Boeing's analysis of flight recorder data, case III.

derived from the airplane's measured performance parameters combined with the motion equation results for the assumed groundspeed profiles. No attempt was made to adjust the derived airplane pitch angles to produce a windfield that would fall within reasonable environmental parameters. Consequently, while the horizontal wind shear demonstrated in case III is reasonable, the 25 fps downdraft at 100 feet AGL is not; a 25 fps downdraft at 100 feet AGL would produce a diverging outflow on the order of 100 knots. It was obvious that surface winds of this magnitude did not occur during this accident.
